SITE ASSESSMENT REPORT
FOR
CYB TOOL SITE
CANTON, WAYNE COUNTY, MICHIGAN
TDD # TO5-9302-012
PAN # EMI1332SAA
DOCUMENT CONTROL NUMBER TAT-05-25-03030

OCTOBER 4, 1993

Prepared For:
Ms. Jan Pfundheller
Deputy Project Officer
Emergency and Enforcement Response Branch
Emergency Support Section
U.S. EPA Region V

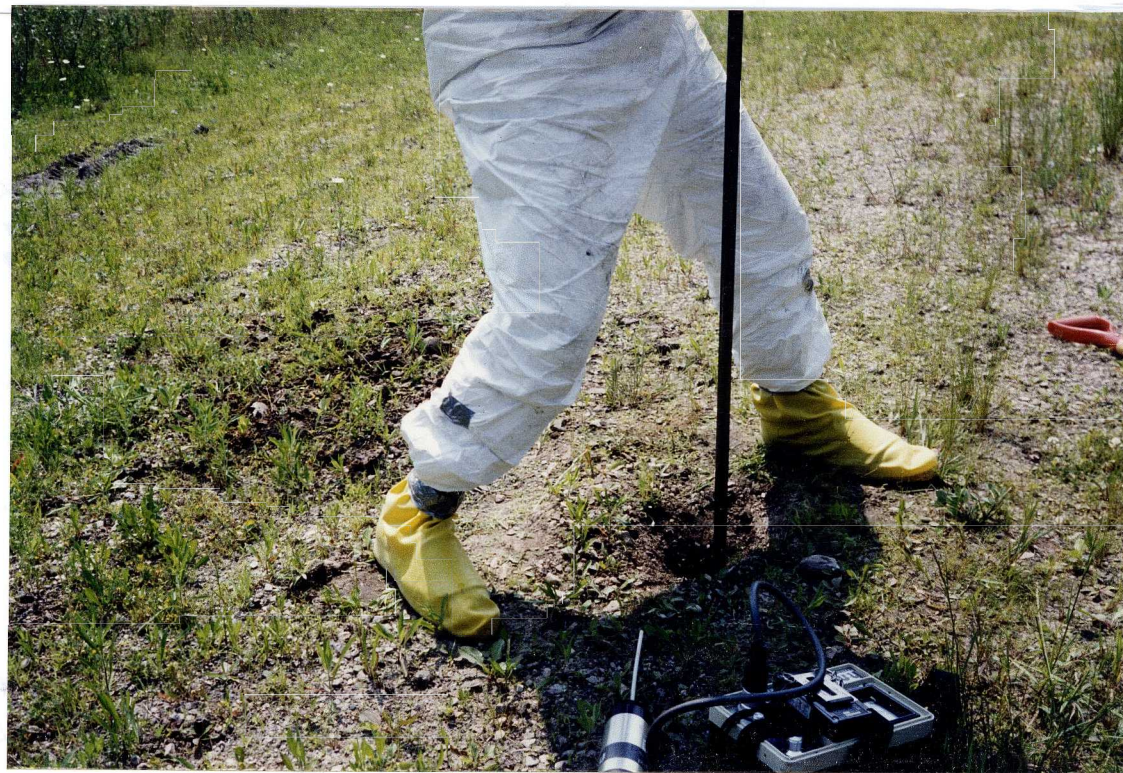
Site: Cyb Tool
 Photo No: 01
 Direction: Northwest
 Camera: Fuji 35mm
 Photographer: Herbert Langer

On June 24, 1993, the TAT arrived back on site and marked the lagoon boundaries. Additions to the original building were found to cover approximately one third of the lagoon. The TAT then used a bucket auger to bore six feet into the marked area. A total of three borings were completed and no indications of waste were detected. The composition of the soil was a clay/sand mix that was consistent with the fill cap at the waste site west of the Cyb Tool site.

Date: 8/3/93
 Subject: TAT Durno uses bucket auger
 to attempt boring into lagoon.

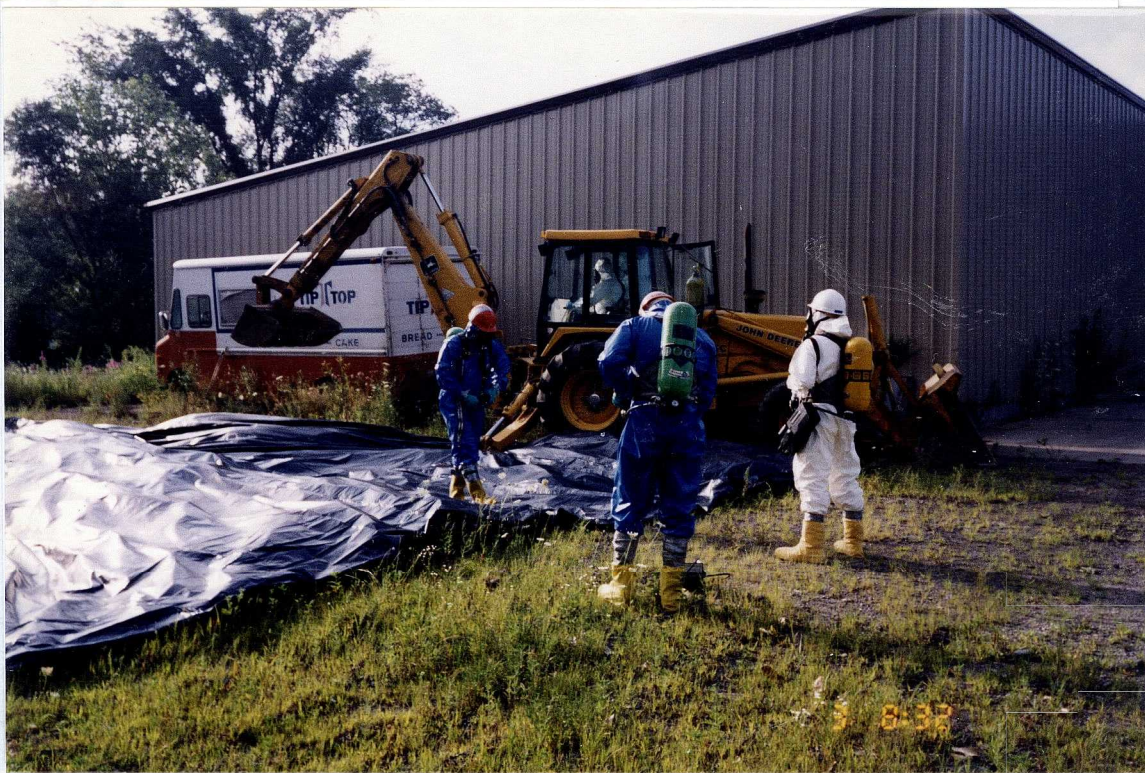
Site: Cyb Tool
Photo No: 03
Direction: Southeast
Camera: Fuji 35mm
Photographer: Herbert Langer

Date: 8/3/93
Subject: Crew prepares to perform
first test excavation into lagoon.

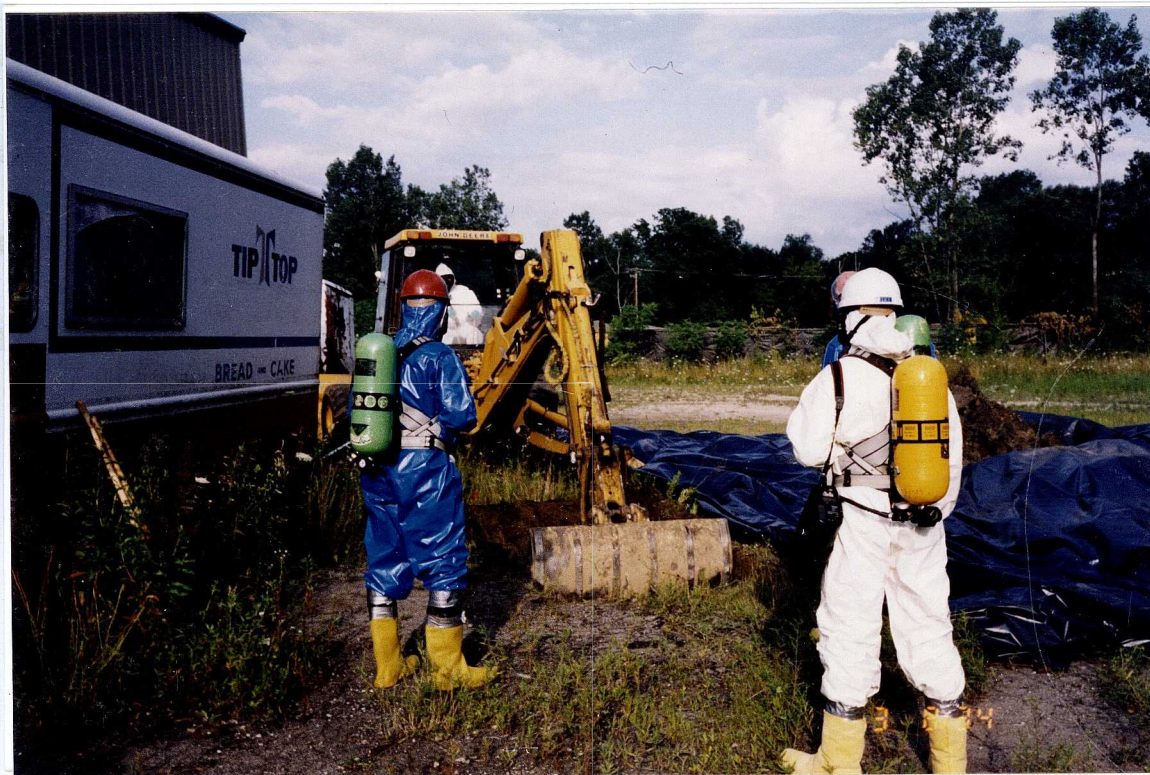
Site: Cyb Tool
Photo No: 04
Direction: West
Camera: Fuji 35mm
Photographer: Mark Durno

The first test excavation was into the west leg of the historic lagoon. The soil encountered during the dig was primarily clay with some sand. Concrete was interspersed throughout the fill material. These observations were consistent with the USDA soil

Date: 8/3/93
Subject: Lagoon test excavation
begins.

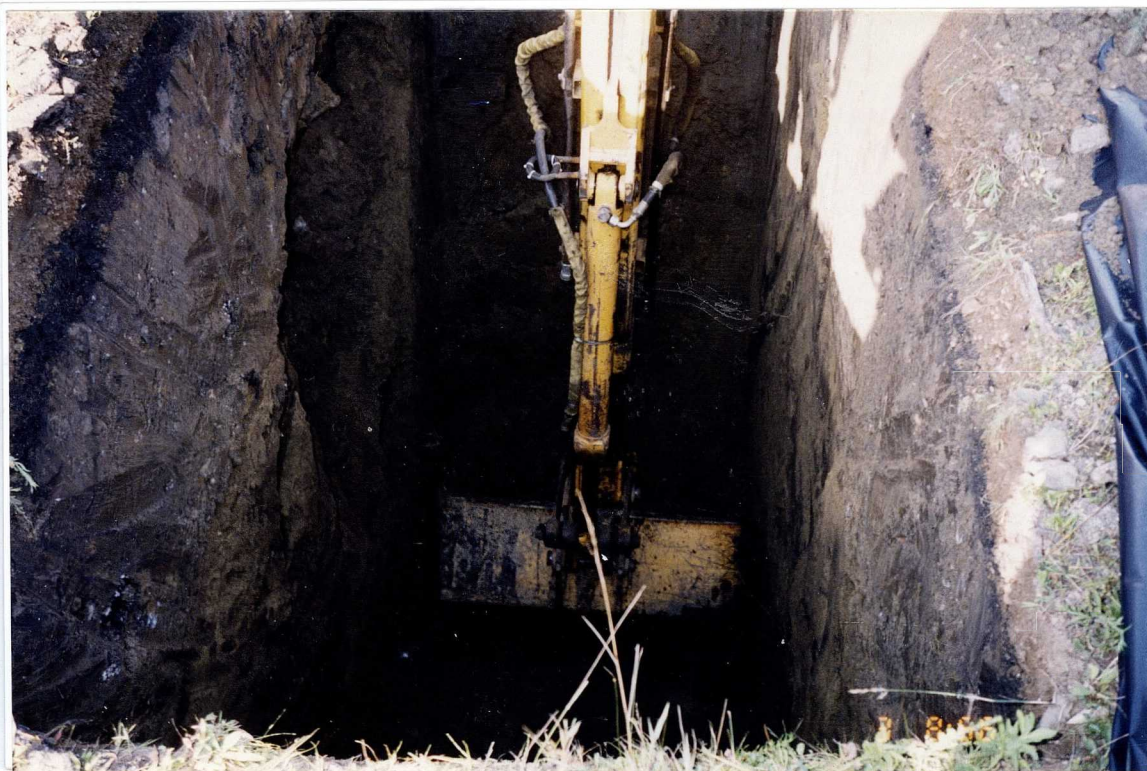
Site: Cyb Tool
 Photo No: 05
 Direction: Down
 Camera: Fuji 35mm
 Photographer: Mike Dieckhaus

Date: 8/3/93
 Subject: Backhoe breaks into stained
 soil in lagoon.

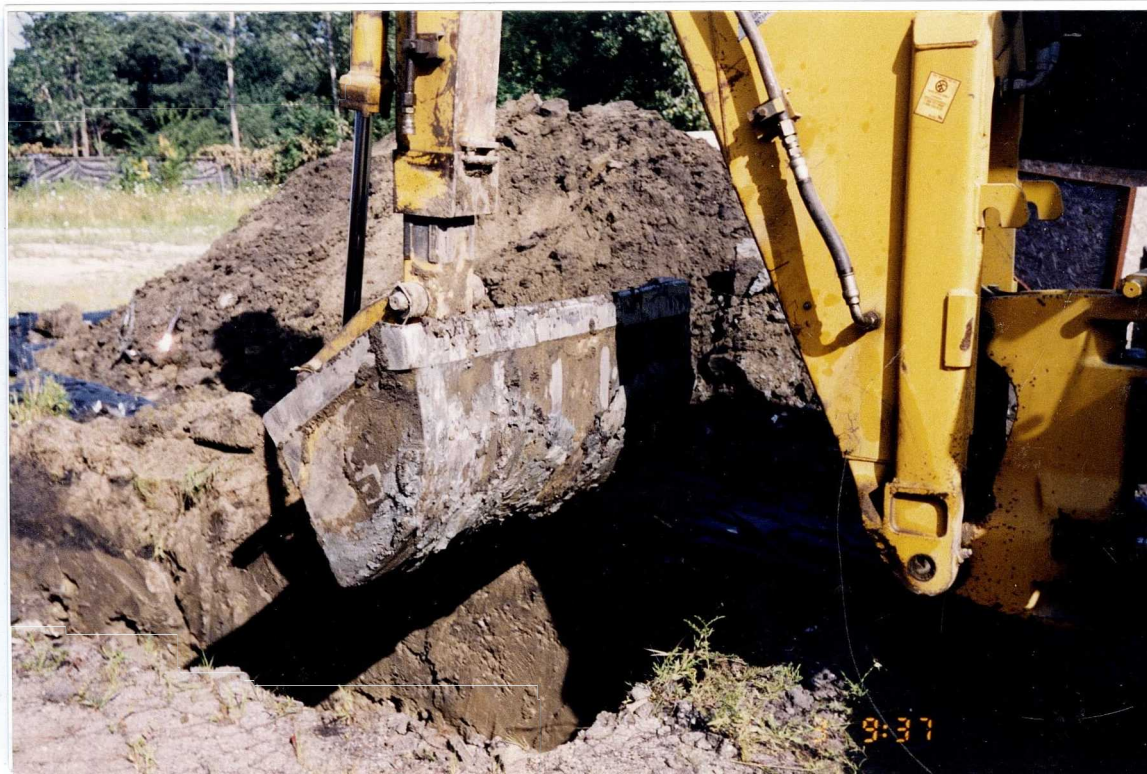
Site: Cyb Tool
 Photo No: 06
 Direction: North
 Camera: Fuji 35mm
 Photographer: Herbert Langer

At a depth of seventeen feet, green material was encountered. The color and texture of the material was consistent with residual plating sludge. Electroplated metal automotive parts were mixed in with the sludge. After collecting a sample of the sludge (sample number CT1), the excavation was backfilled.

Date: 8/3/93
 Subject: Green stained soil on
 backhoe bucket.

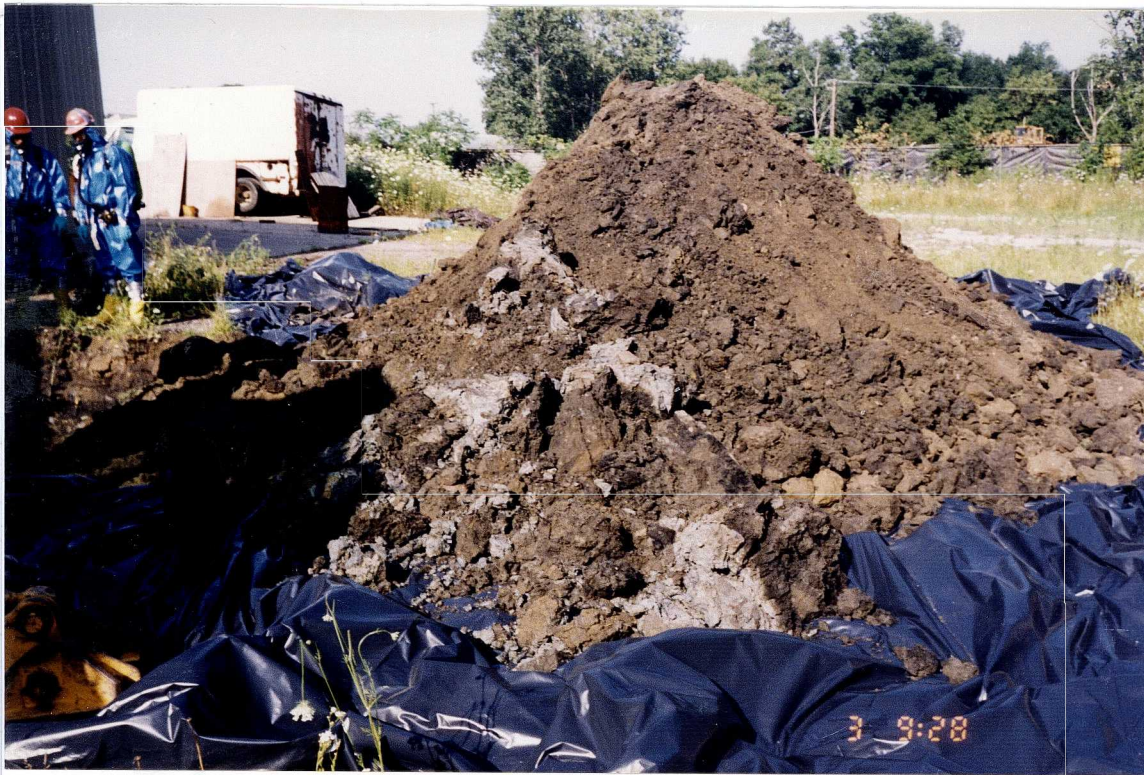
Site: Cyb Tool
 Photo No: 07
 Direction: West
 Camera: Fuji 35mm
 Photographer: Mark Durno

Date: 8/3/93
 Subject: Green stained soil in
 excavated soil.

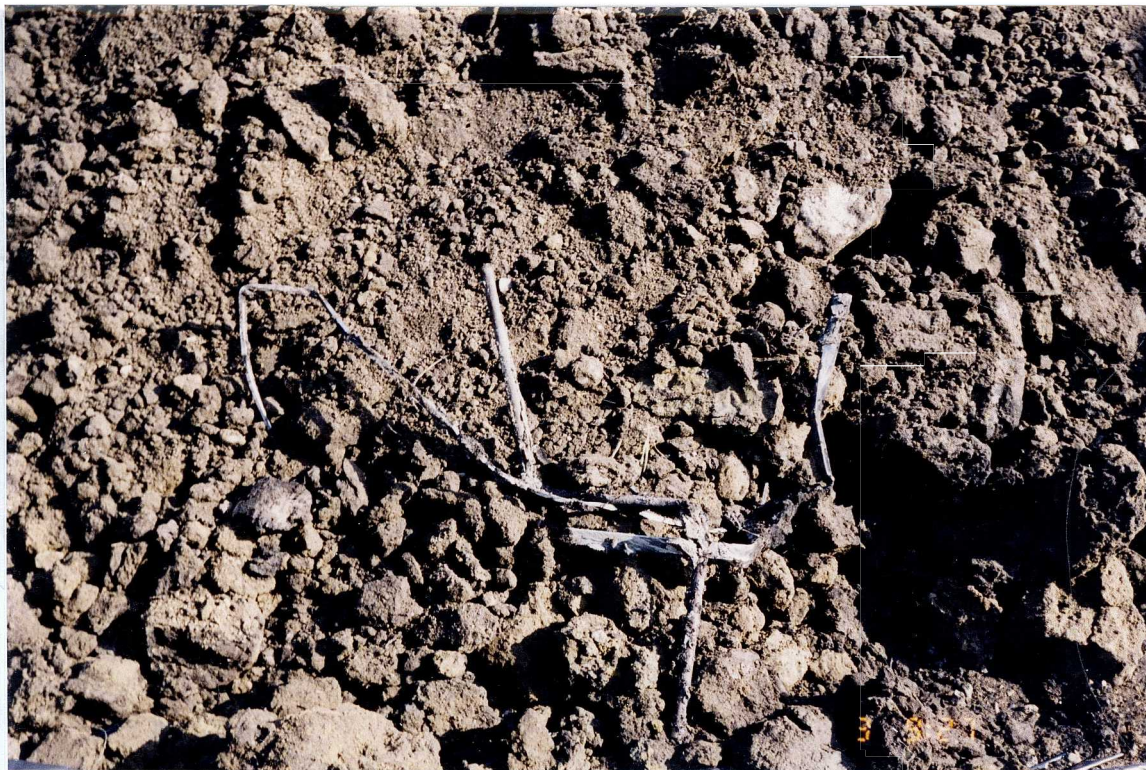
Site: Cyb Tool
 Photo No: 08
 Direction: North
 Camera: Fuji 35mm
 Photographer: Herbert Langer

Date: 8/3/93
 Subject: Electroplated Steel parts
 pulled from excavation with the
 stained soil.

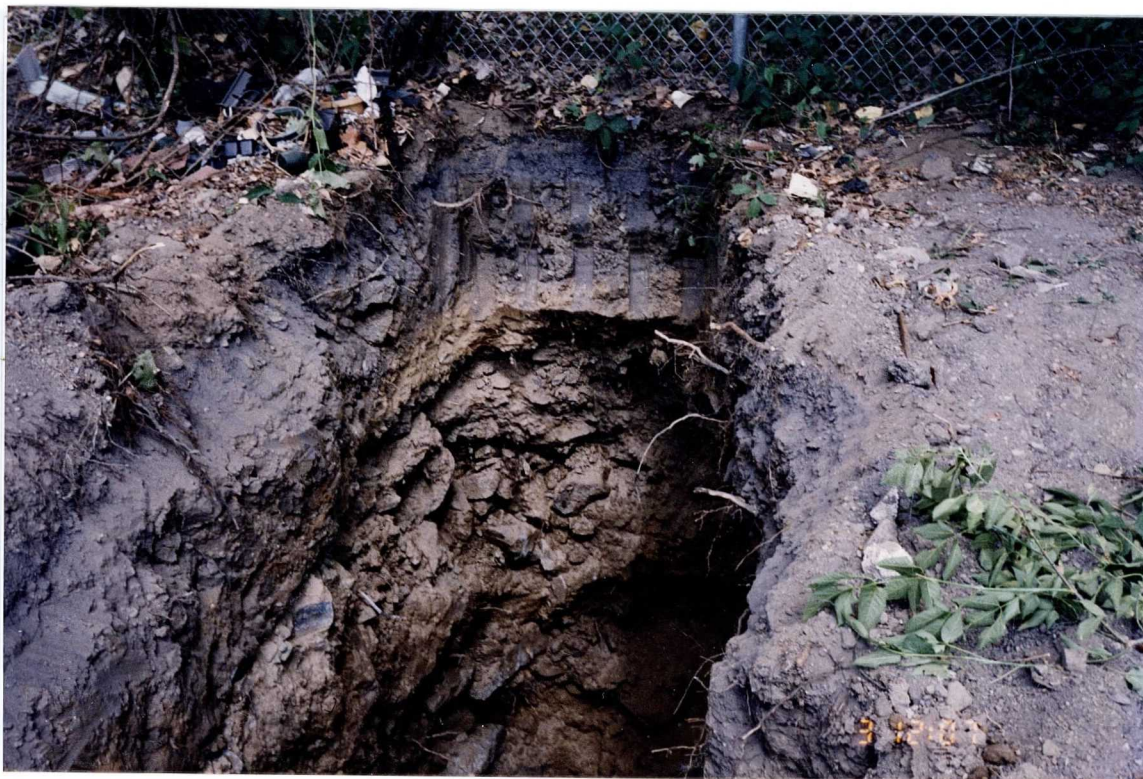
Site: Cyb Tool
 Photo No: 10
 Direction: Down
 Camera: Fuji 35mm
 Photographer: Mark Durno

Date: 8/3/93
 Subject: Concrete, clay, and sand
 fill material found in excavation
 two.

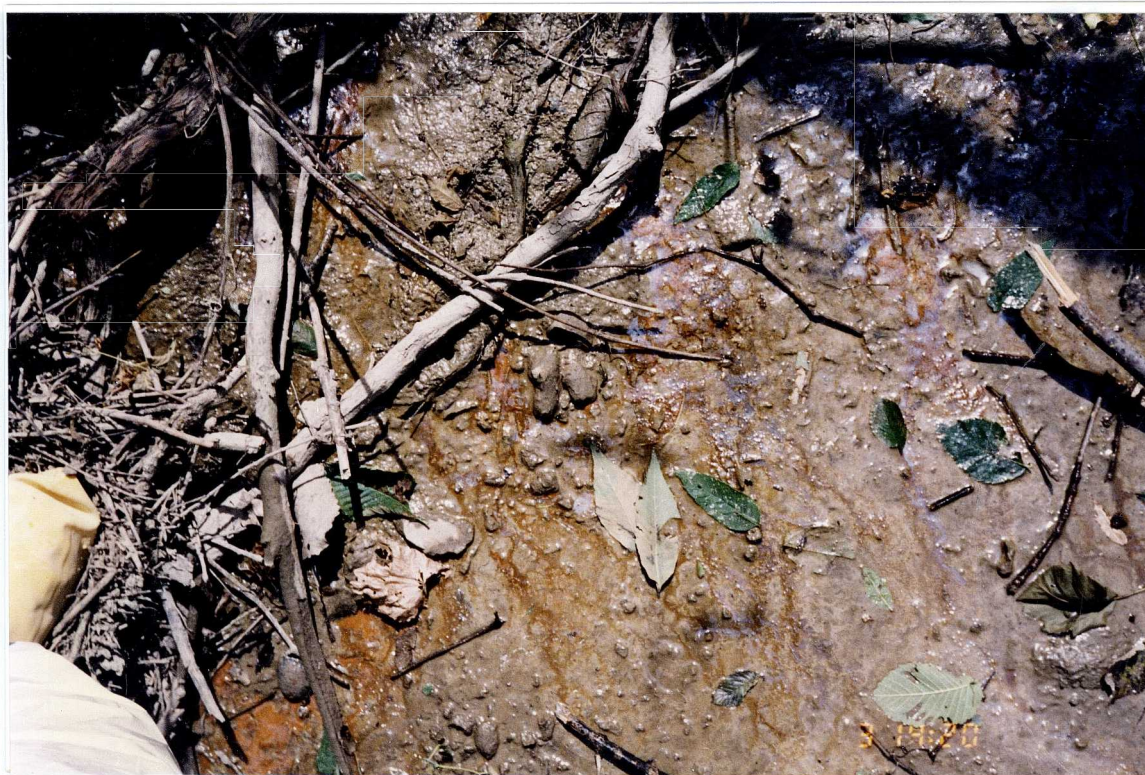
Site: Cyb Tool
 Photo No: 12
 Direction: Down
 Camera: Fuji 35mm
 Photographer: Mark Durno

The fence north of the second excavation was removed, and the third excavation was initiated. The excavation was near the river and was continued to the water table. No waste was encountered. Excavation four was near the top of the hillside between excavations two and three. The excavation was continued until virgin soil was encountered. Fill soil and concrete were the only materials found in both excavations. The fifth excavation was directed in a northeast angle from excavation four. The trench was dug from the elevation of excavation three to the elevation of excavation four. The excavation was continued until groundwater was encountered. Excavated fill materials were consistent with excavations two, three, and four. All excavations were backfilled, and the sub-contractor and the TAT departed the site.

Date: 8/3/93
 Subject: Groundwater is encountered
 in excavation three.

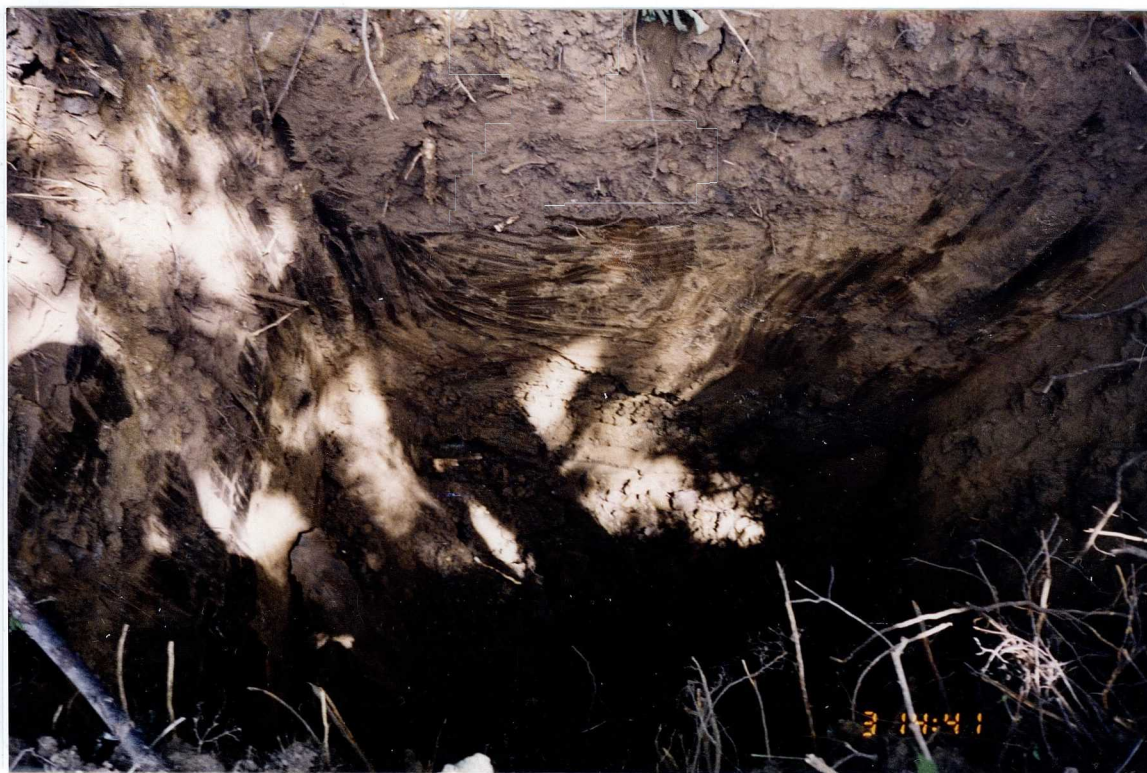
Site: Cyb Tool
 Photo No: 13
 Direction: Down
 Camera: Fuji 35mm
 Photographer: Mark Durno

Date: 8/3/93
 Subject: Fill soil found in sixth excavation trench.

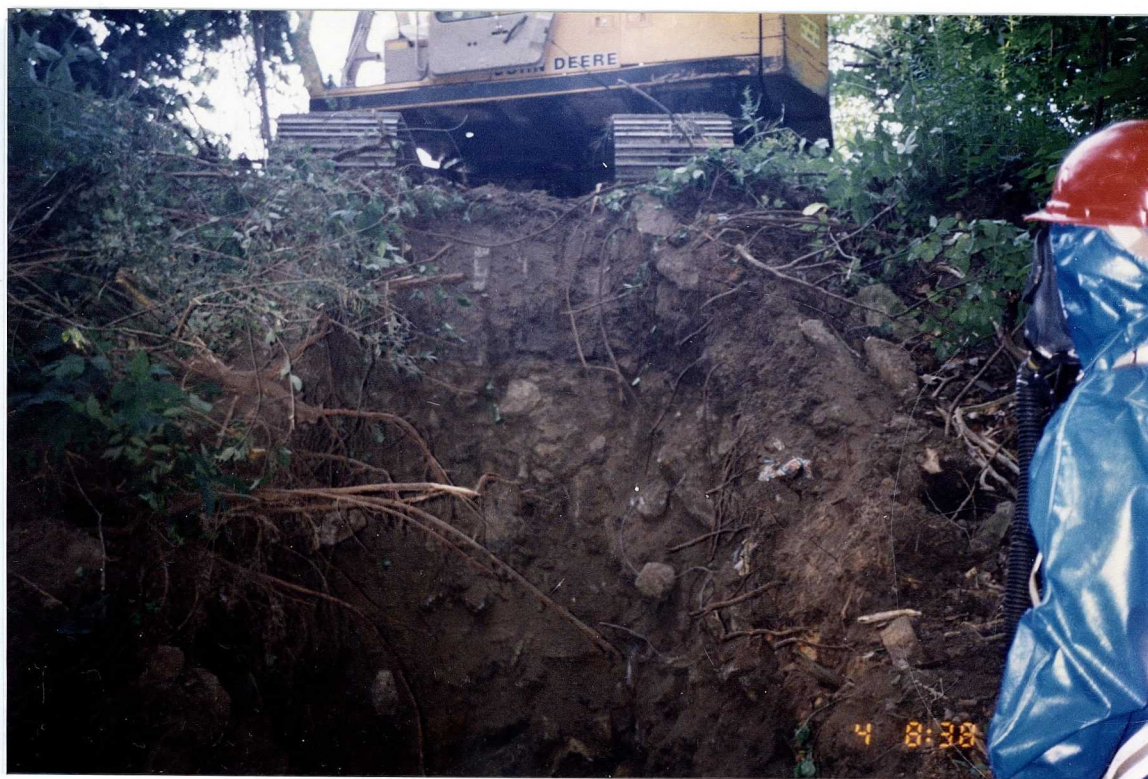
Site: Cyb Tool
 Photo No: 14
 Direction: South
 Camera: Fuji 35mm
 Photographer: Mark Durno

Excavation seven was performed at the eastern edge of the site. The entire site slopes slightly in this direction. Again the fence had to be removed and the excavation trench extended from the river elevation to the top of the fill. Concrete debris and fill soil were the only materials found in the trench down to virgin soil. Sample CT3 was collected from this fill soil.

Date: 8/4/93
 Subject: Trench seven completed, typical sand, clay, and concrete fill material is exposed.

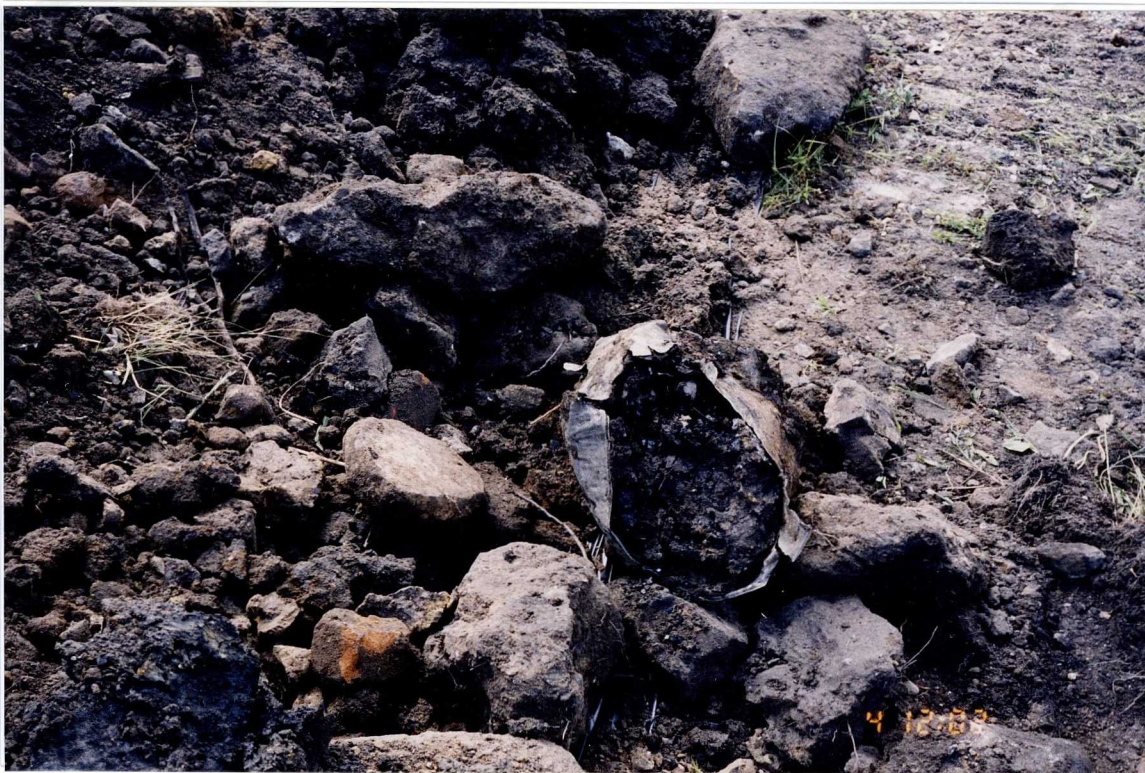
Site: Cyb Tool
 Photo No: 15
 Direction: down
 Camera: Fuji 35mm
 Photographer: Mark Durno

The OSC then directed that a trench be dug that traversed the remaining length of the fill area, along the west fence line. The trench was dug approximately seventy feet long, fifteen feet deep, and five feet wide. Two unlabeled containers were found with the fill soil and concrete. The first container yielded photoionization detector (PID) readings twelve units above background. The second yielded PID readings of 400 units. Samples were collected from both containers and were numbered CT5 and CT4 respectively.

Date: 8/4/93
 Subject: Container from excavation
 trench eight. Sample CT4 was
 collected from this container.

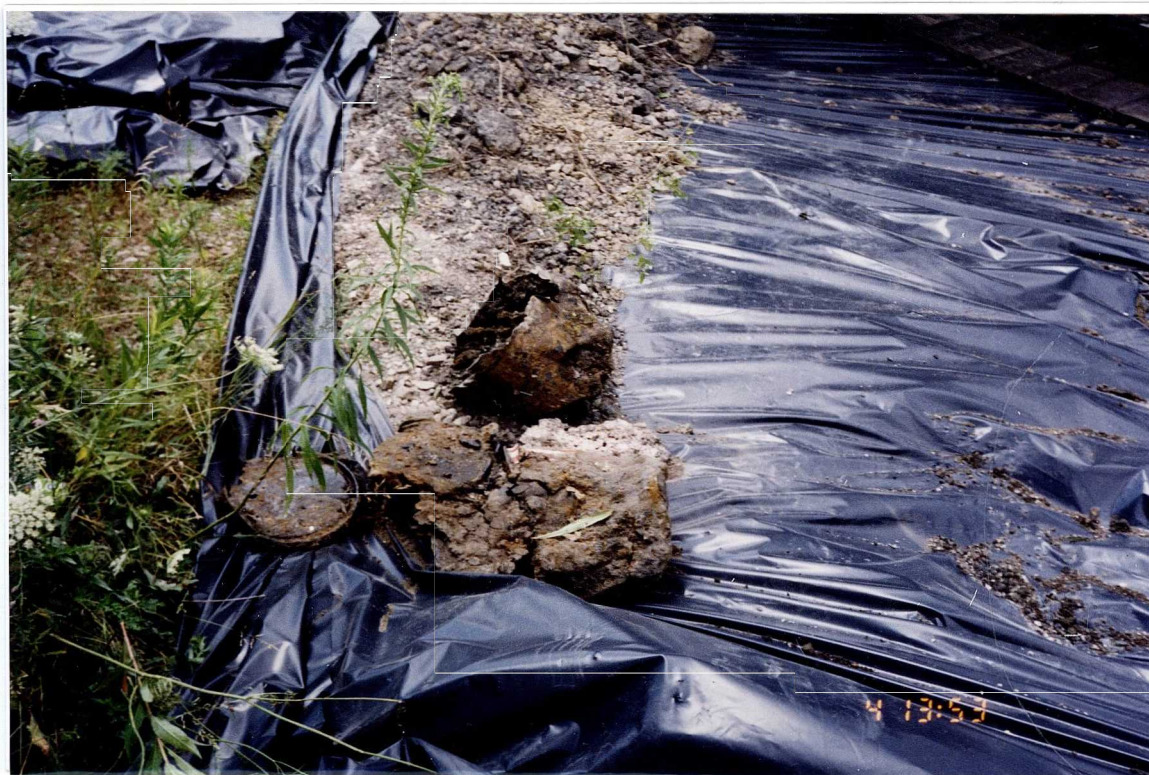
Site: Cyb Tool
 Photo No: 16
 Direction: Down
 Camera: Fuji 35mm
 Photographer: Mark Durno

Date: 8/4/93
 Subject: Second container from trench
 eight. Sample CT5 was collected from
 this container.

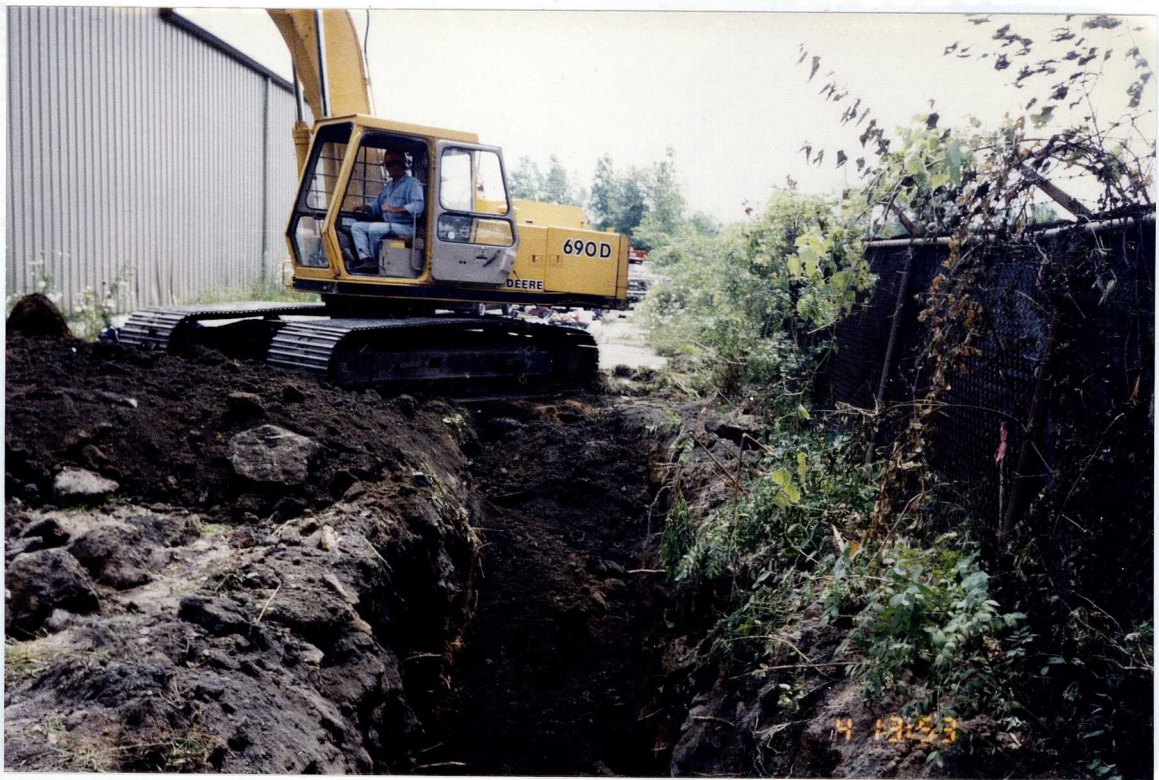
Site: Cyb Tool
 Photo No: 17
 Direction: South
 Camera: Fuji 35mm
 Photographer: Mark Durno

Date: 8/4/93
 Subject: Trench eight excavation is complete.

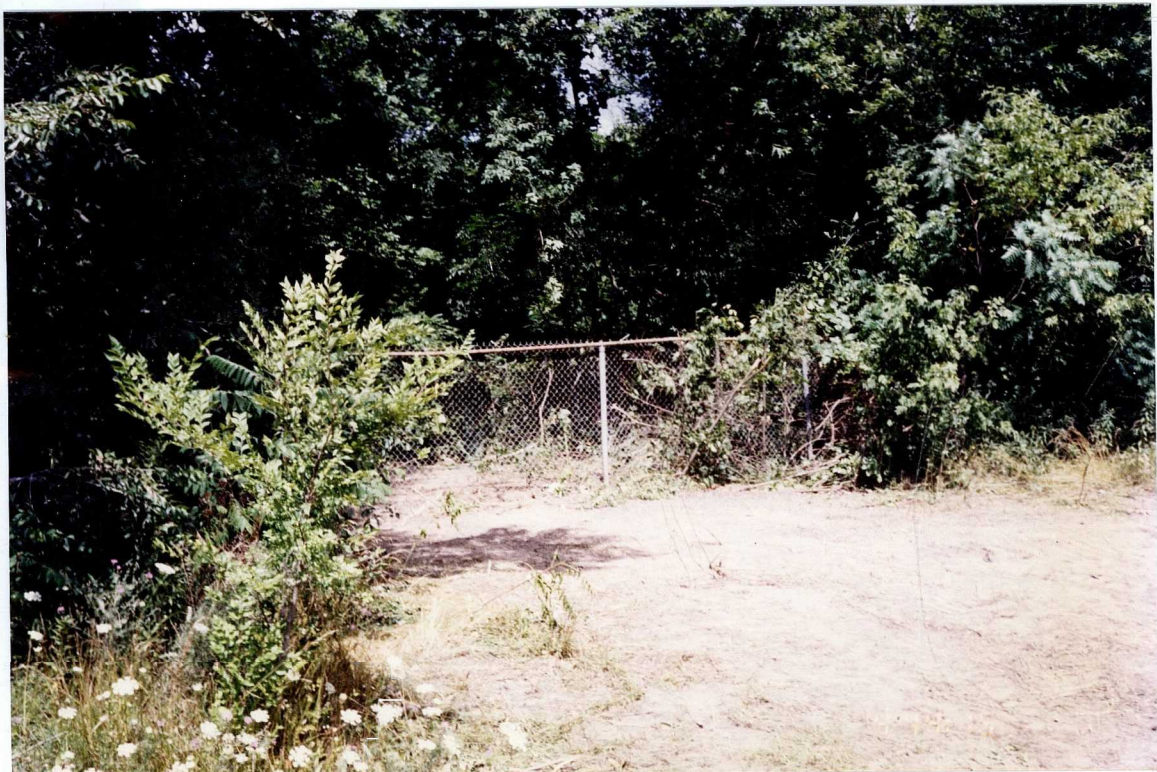
Site: Cyb Tool
 Photo No: 18
 Direction: North
 Camera: Fuji 35mm

Date: 8/4/93
 Subject: Fence repair is complete.

The sub-contractor then backfilled all excavations and returned the site to the original grade. Remaining soils were placed in piles above the excavation areas to allow for settling. All fencing was replaced and secured. The sub-contractor and the TAT then departed the site. The TAT returned to the site August 5, 1993, to add additional securing to the fence. The TAT then delivered the investigation samples to the laboratory.
